ISCKMC 2022**International Scientific Congress «KNOWLEDGE, MAN AND CIVILIZATION»****"BATTLE TOWER AT FOOT OF CAPE OF RUINS OF
MALCHIST", MONUMENT RESTORATION**

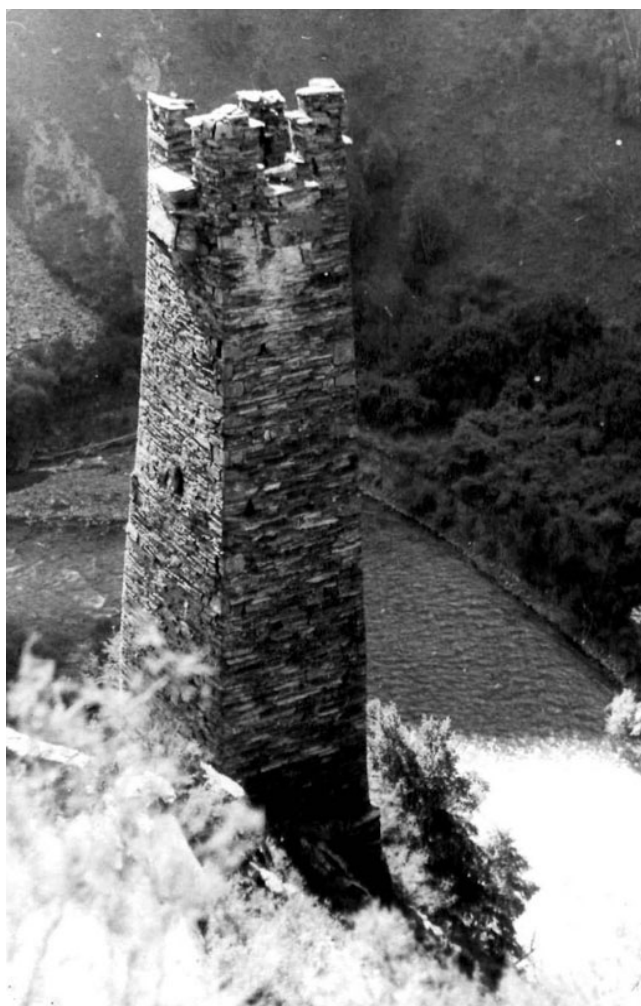
Figure 1. Photo taken by an unknown photographer in 1980

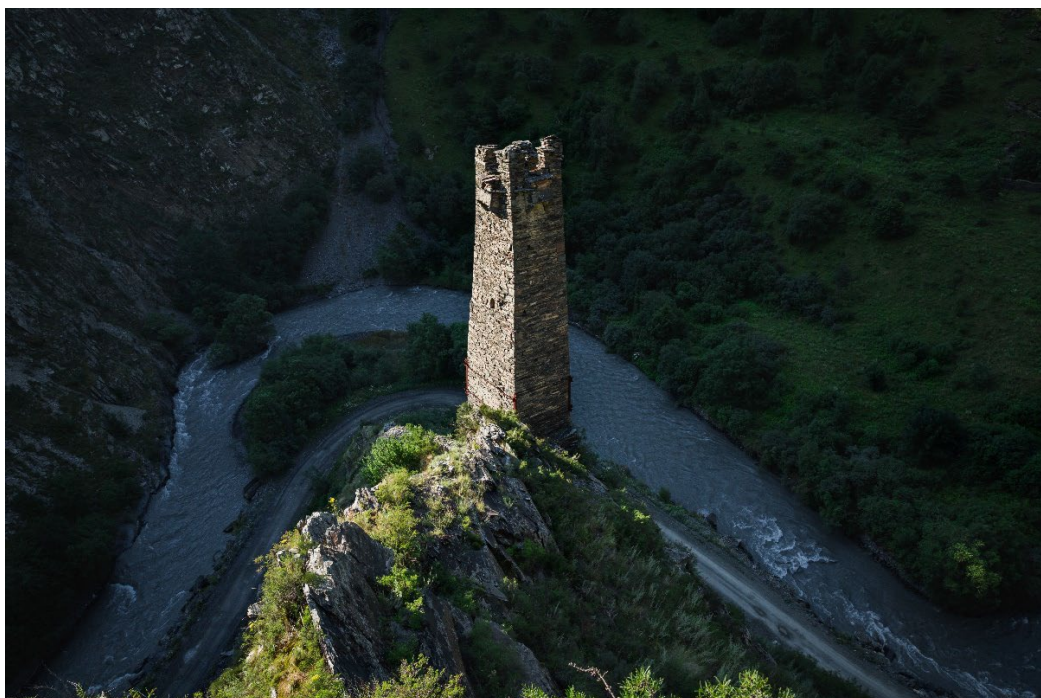
Figure 2. Photo taken in 2017 before repair and restoration

The walls of the tower made of natural stones are 600 mm thick. The roof and ceilings are absent, on the southern facade there are entrances to the 1st and 2nd tiers, window openings, viewing slots, and loopholes. The tower base is a cliff, sharply reduced in area under the effect of atmospheric precipitation, the tower exhibits a roll and longitudinal cracks. The roof and ceilings are completely destroyed, the walls are affected by precipitation. Vertical and inclined cracks run along the facades, going from the base to the top.

The mortar in the upper part of the walls is washed out; potholes after bullet shooting during the 1st and 2nd Chechen campaign can be observed on the facades; the masonry is covered with mosses and lichens; there are no filling openings. In the 2010s, during recovery operation, a metal bandage of corners fastened with reinforcing bars was installed along the bottom of the walls. Category of the technical condition of the masonry – emergency.

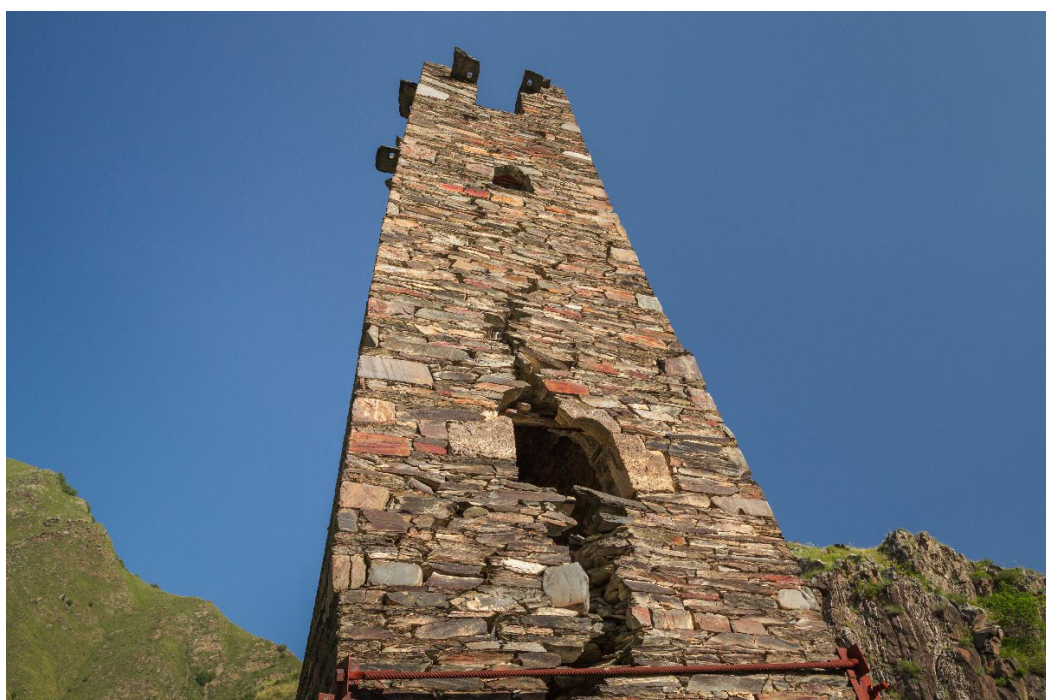
Figure 3. Photo taken in 2017 before repair and restoration

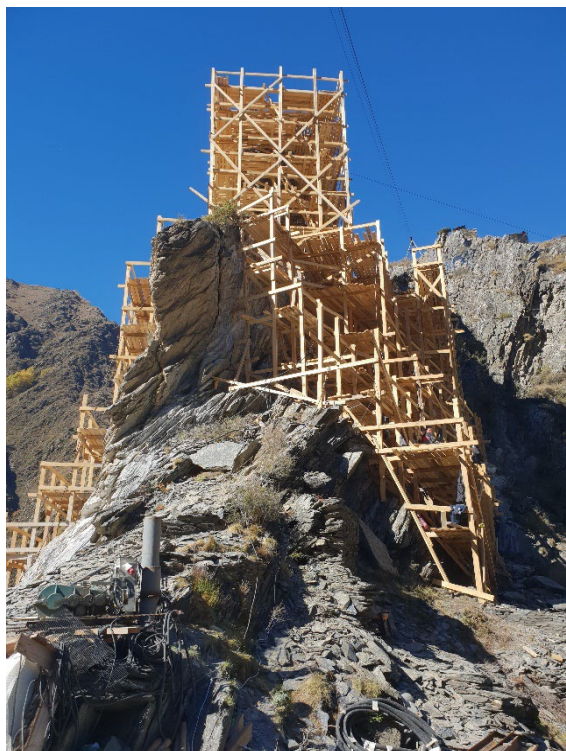
Figure 4. Photo taken in 2018 during restoration

The tower restoration project provides for the removal of masonry, injection reinforcement, the reconstruction of parapets, wooden floors, the installation of PVC membrane roofing on a wooden base, the restoration of carpentry fillings for door and window openings.

Injection reinforcement of masonry is carried out using special mortar. Injection tubes are installed in holes drilled in the masonry, with a step of 400/400 in a checkerboard pattern, and under pressure up to 3 atmospheres, the mortar mixture is injected to make the masonry monolithic. Prior to injection reinforcement, grouting and repair of joints must be carried out. The suture mortar consists of dolomite flour (20 %); lime slaked for at least 3 years (40 %); cement M500 (20 %); washed shale sand (20 %).

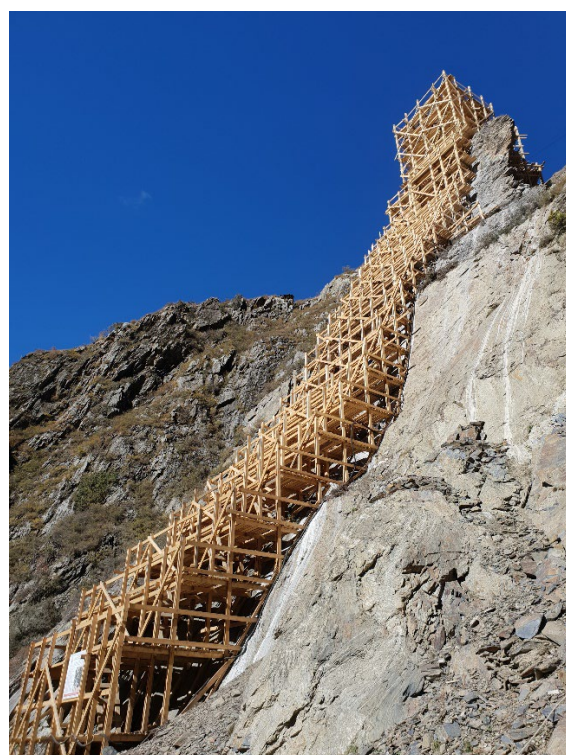
Figure 5. Photo taken in 2018 during restoration

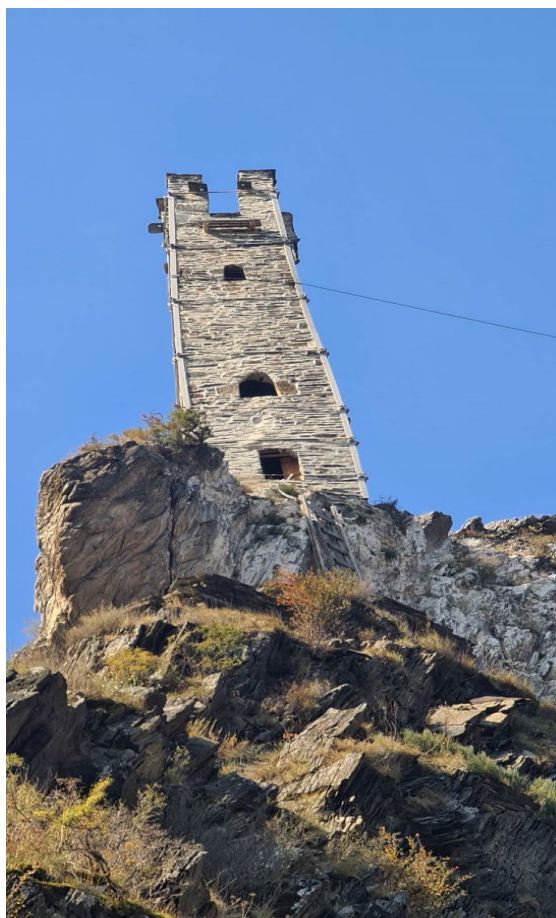
Figure 6. Photo taken in 2018 after restoration

The design solutions proposed in the project have been fully implemented. The performed work on the restoration and reconstruction of the tower will preserve the structures for posterity and will enable adapting and using tower complexes.

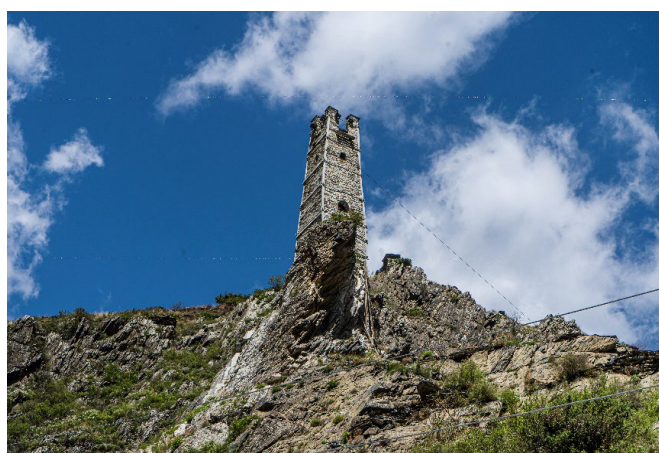
Figure 7. Photo taken in 2018 after restoration
